Durability of two-component backfill grout: An experimental study

ABSTRACT: Two-component grout is widely used in mechanized tunnelling to fill the annular gap behind the segmental lining. Besides the numerous advantages of this technology, it is well known that this type of mortar is subject to rapid degradation processes when exposed to air, even for short periods of time. This is not a concern under normal operating conditions, i.e. underground and often below the water table, but it may be detrimental to the quality of the backfilling in case part of the grout is temporarily exposed to air during the construction phases. In lack of dedicated standards, the purpose of this work is to share a laboratory experience on a topic that has not been fully addressed in the literature. The research activity presented in this paper was specifically designed to evaluate the effect of exposure to air and dry soil on a high-performance two-component mortar. The experimental study entailed the execution of visual inspections, UCS tests and mineralogical analyses on small and full-scale specimens subjected to specific exposure environments for an observation period of six months. The results s

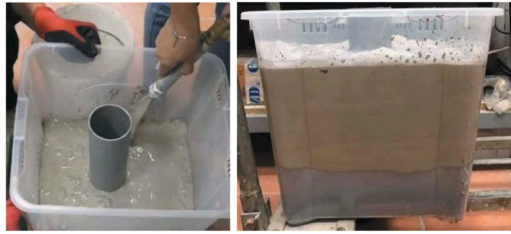
Figure 3. Pictures of the full-scale set-up.

After 40 days of curing in sealed conditions, the PVC pipe was extracted and replaced with a smaller slotted pipe, leaving a gap of about 2 mm between the hole wall and the external surface of the drain. The system thus made was then kept at a temperature of 25 °C and relative humidity, hr , of 70% for six months, during which visual inspection and UCS tests were performed at regular intervals.

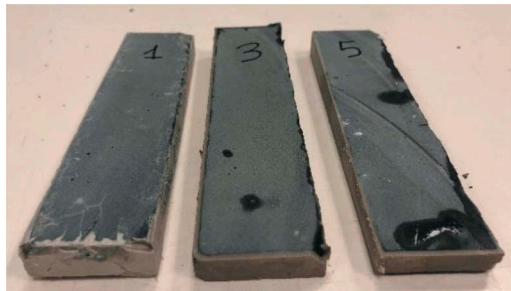
As illustrated in Figure 4, which shows longitudinal sections of sawn prisms, the samples presented a dry/discolored external layer, while the inside appeared fresh.

Figure 4. Pictures of sections of samples sawn after exposure to air at different values of relative humidity, from the left: 50%, 90% and 98%.

The extent of the discolouration, localized at the exposed faces, is greater in the specimens exposed to lower humidity values ($hr=50\%$), as could be expected. Beside the external discoloring, the exposure at $hr=50\%$ produced the formation of cracks propagating from the free base inwards.

The thickness of the altered layer after two months was about 2 mm, but this did not translate in a deterioration of the performance, even for the samples kept at the lowest humidity.

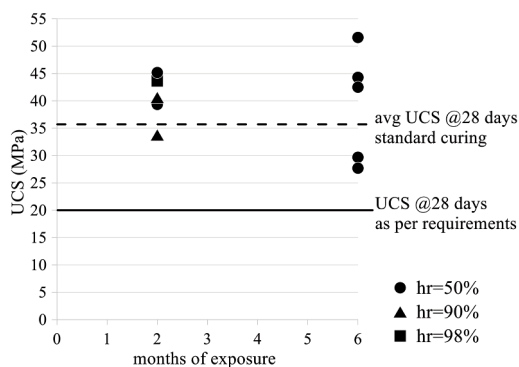
The results of the UCS tests carried out on cubic samples sawn from the prisms are presented in Table 2 and Figure 5. It can be observed that the UCS of the control sample (cured in water for the same period) is about 36 MPa, congruent with the average UCS at 28 days of this mix, and that after two months of exposure all samples provided results comparable or above this value, in the range 34-45 MPa.

Figure 5. Results of UCS tests after two and six months of exposure to air at relative humidity = 50%.

As anticipated, once seen the cracks proceeding from the exposed face of the samples cured at hr=50%, it was decided to extend the observation period up to six months. The extent of the altered layer grew, producing measurable damages to the strength of the cubic samples containing the exposed surface; in fact, as it can be noted from Table 2 and Figure 5, the UCS values measured on the external portion of the prisms (28 and 30 MPa) are lower than the UCS measured on the internal portion of the same specimens (42-52 MPa).

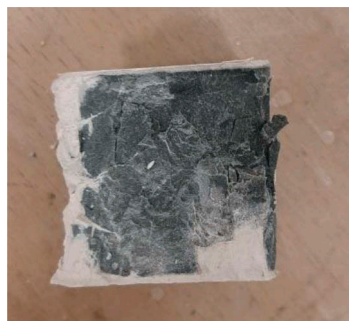
A picture taken after the UCS test of a cubic sample containing the exposed face is shown in Figure 6. It's worth noting that the test was conducted putting the altered surface parallel to the vertical axis in order to have regular surfaces on which apply the load. Of course, this could have an influence on the results.

Figure 6. Broken sample with an exposed surface.

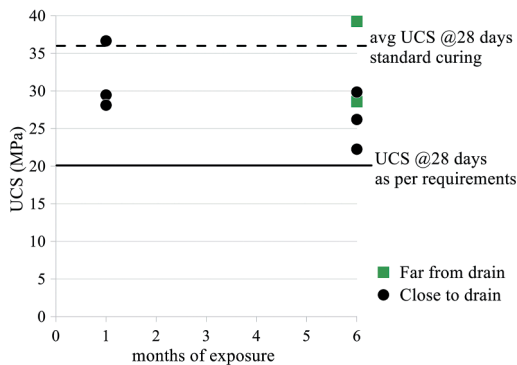
During the first and last inspection, portion of the block near the drainage hole were sawn to obtain cubic samples for UCS tests. The results are reported in Table 4 and Figure 8.

Figure 8. UCS values after 1 and 6 months of exposure.

The measured UCS values, even if always higher than the threshold of 20 MPa set by performance requirements, are generally below the average UCS expected for this mix design at 28 days. This difference may be due to the preparation of the block, which entailed the injection of a huge volume of grout in a single step and a dry, even if sealed, curing. These conditions made the formation of joints and small defects in the block practically unavoidable. Also, the presence of these joints made quite difficult the preparation of cubic samples from the block (from which the modest number of tests that could be executed).

The result show that a reduction of strength due to the exposure to air can be detected comparing the UCS values obtained at different inspections. In fact, after six months of exposure, the samples closer to the hole had an average UCS of 26 MPa, about 17% lower than that of the samples taken close to the hole after one month (31 MPa). Also, visual inspection allowed to observe that the failure of these samples occurred along pre-existing surfaces, while samples retrieved beyond a layer of about 10 cm from the drainage hole provided higher UCS values and appeared fresh after the tests, as shown in Figure 9.

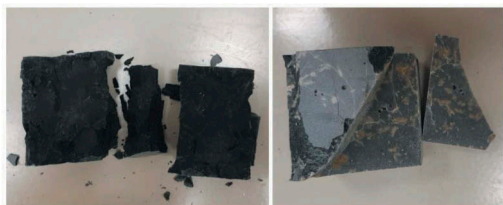
Figure 9. Pictures of samples retrieved from the full-scale block. On the left a sample taken far from the drainage hole, on the right one taken close to it.
